Cost Analysis for Alternatives for Tangerine Rd West End Regional Drainage Study

**OPERATION, MAINTENANCE, AND REPAIR PLAN
FOR
THE TANGERINE ROAD WEST END REGIONAL DRAINAGE SYSTEM
TOWN OF MARANA, ARIZONA**

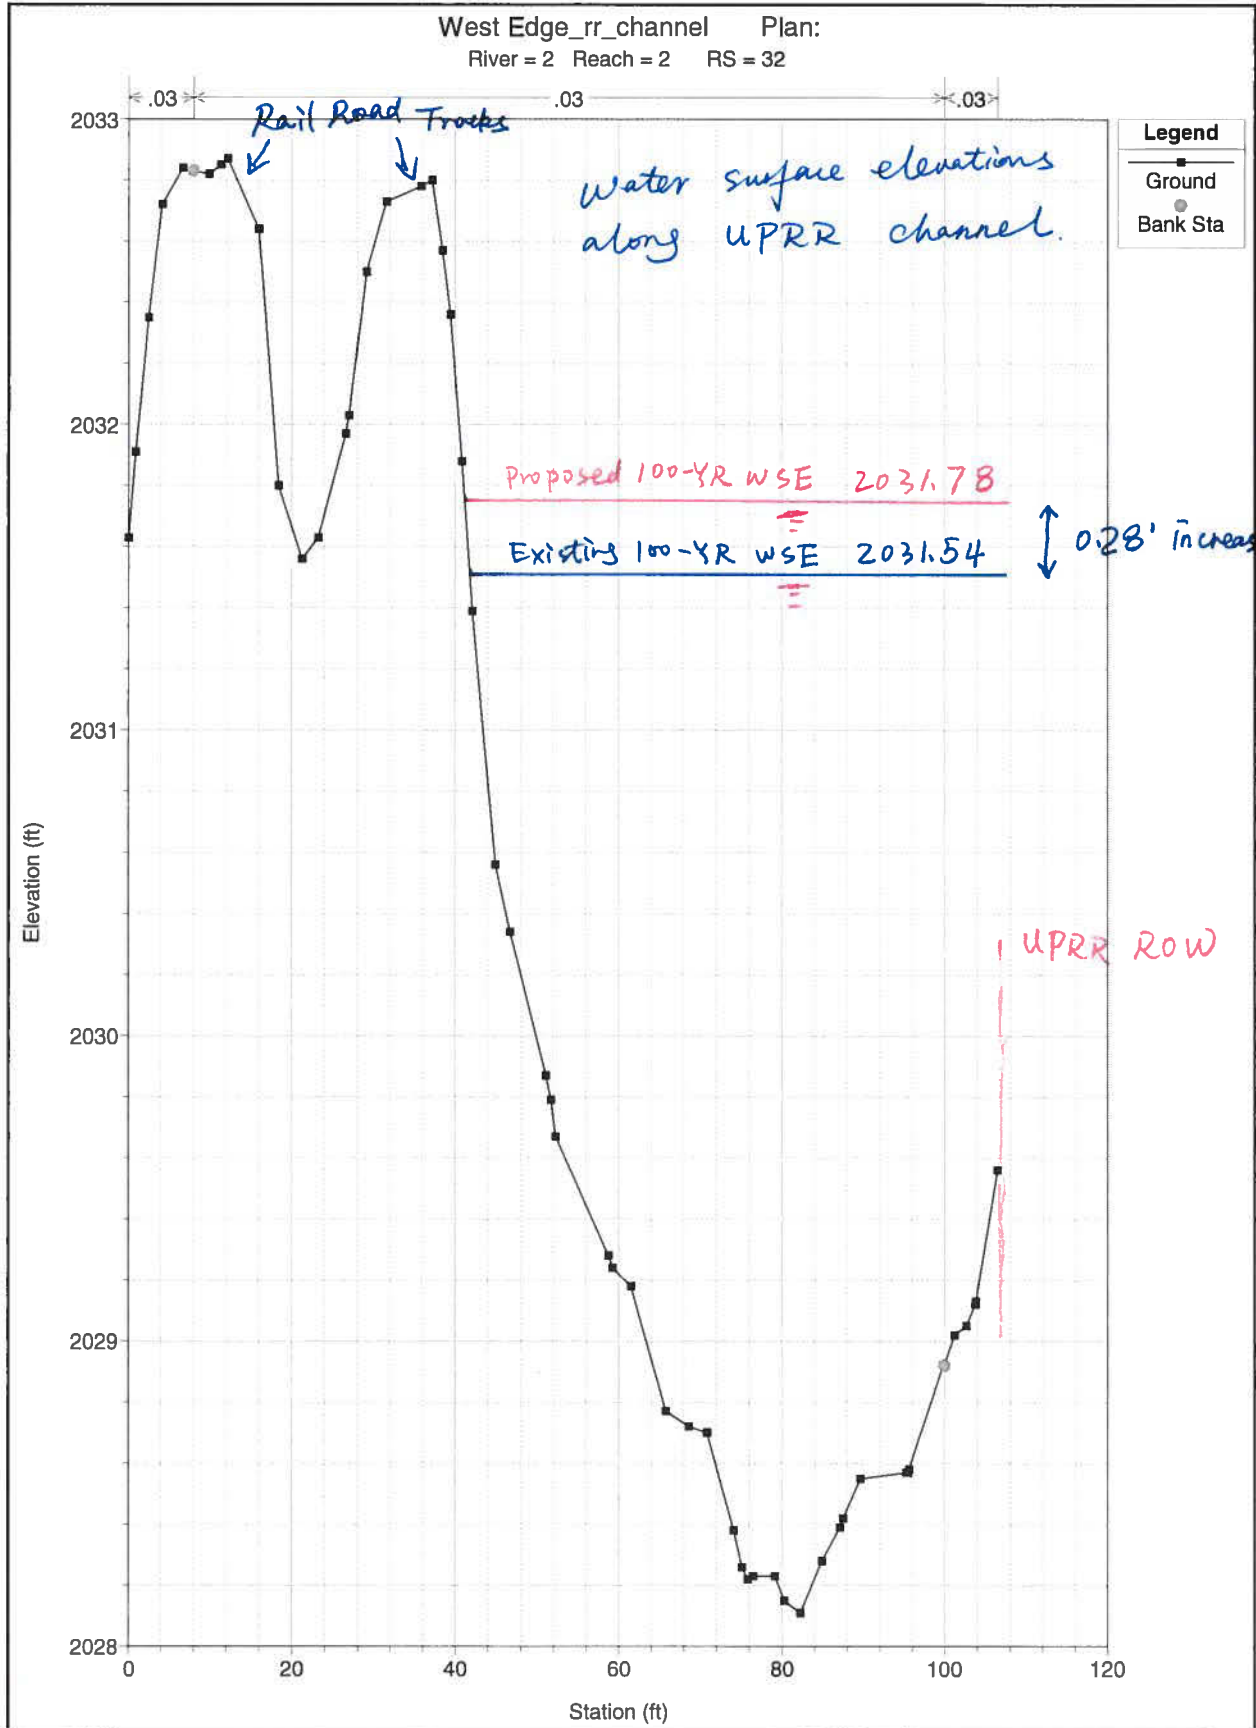
Cross-section B-B [located at about 3250 feet north of Tangerine Rd]

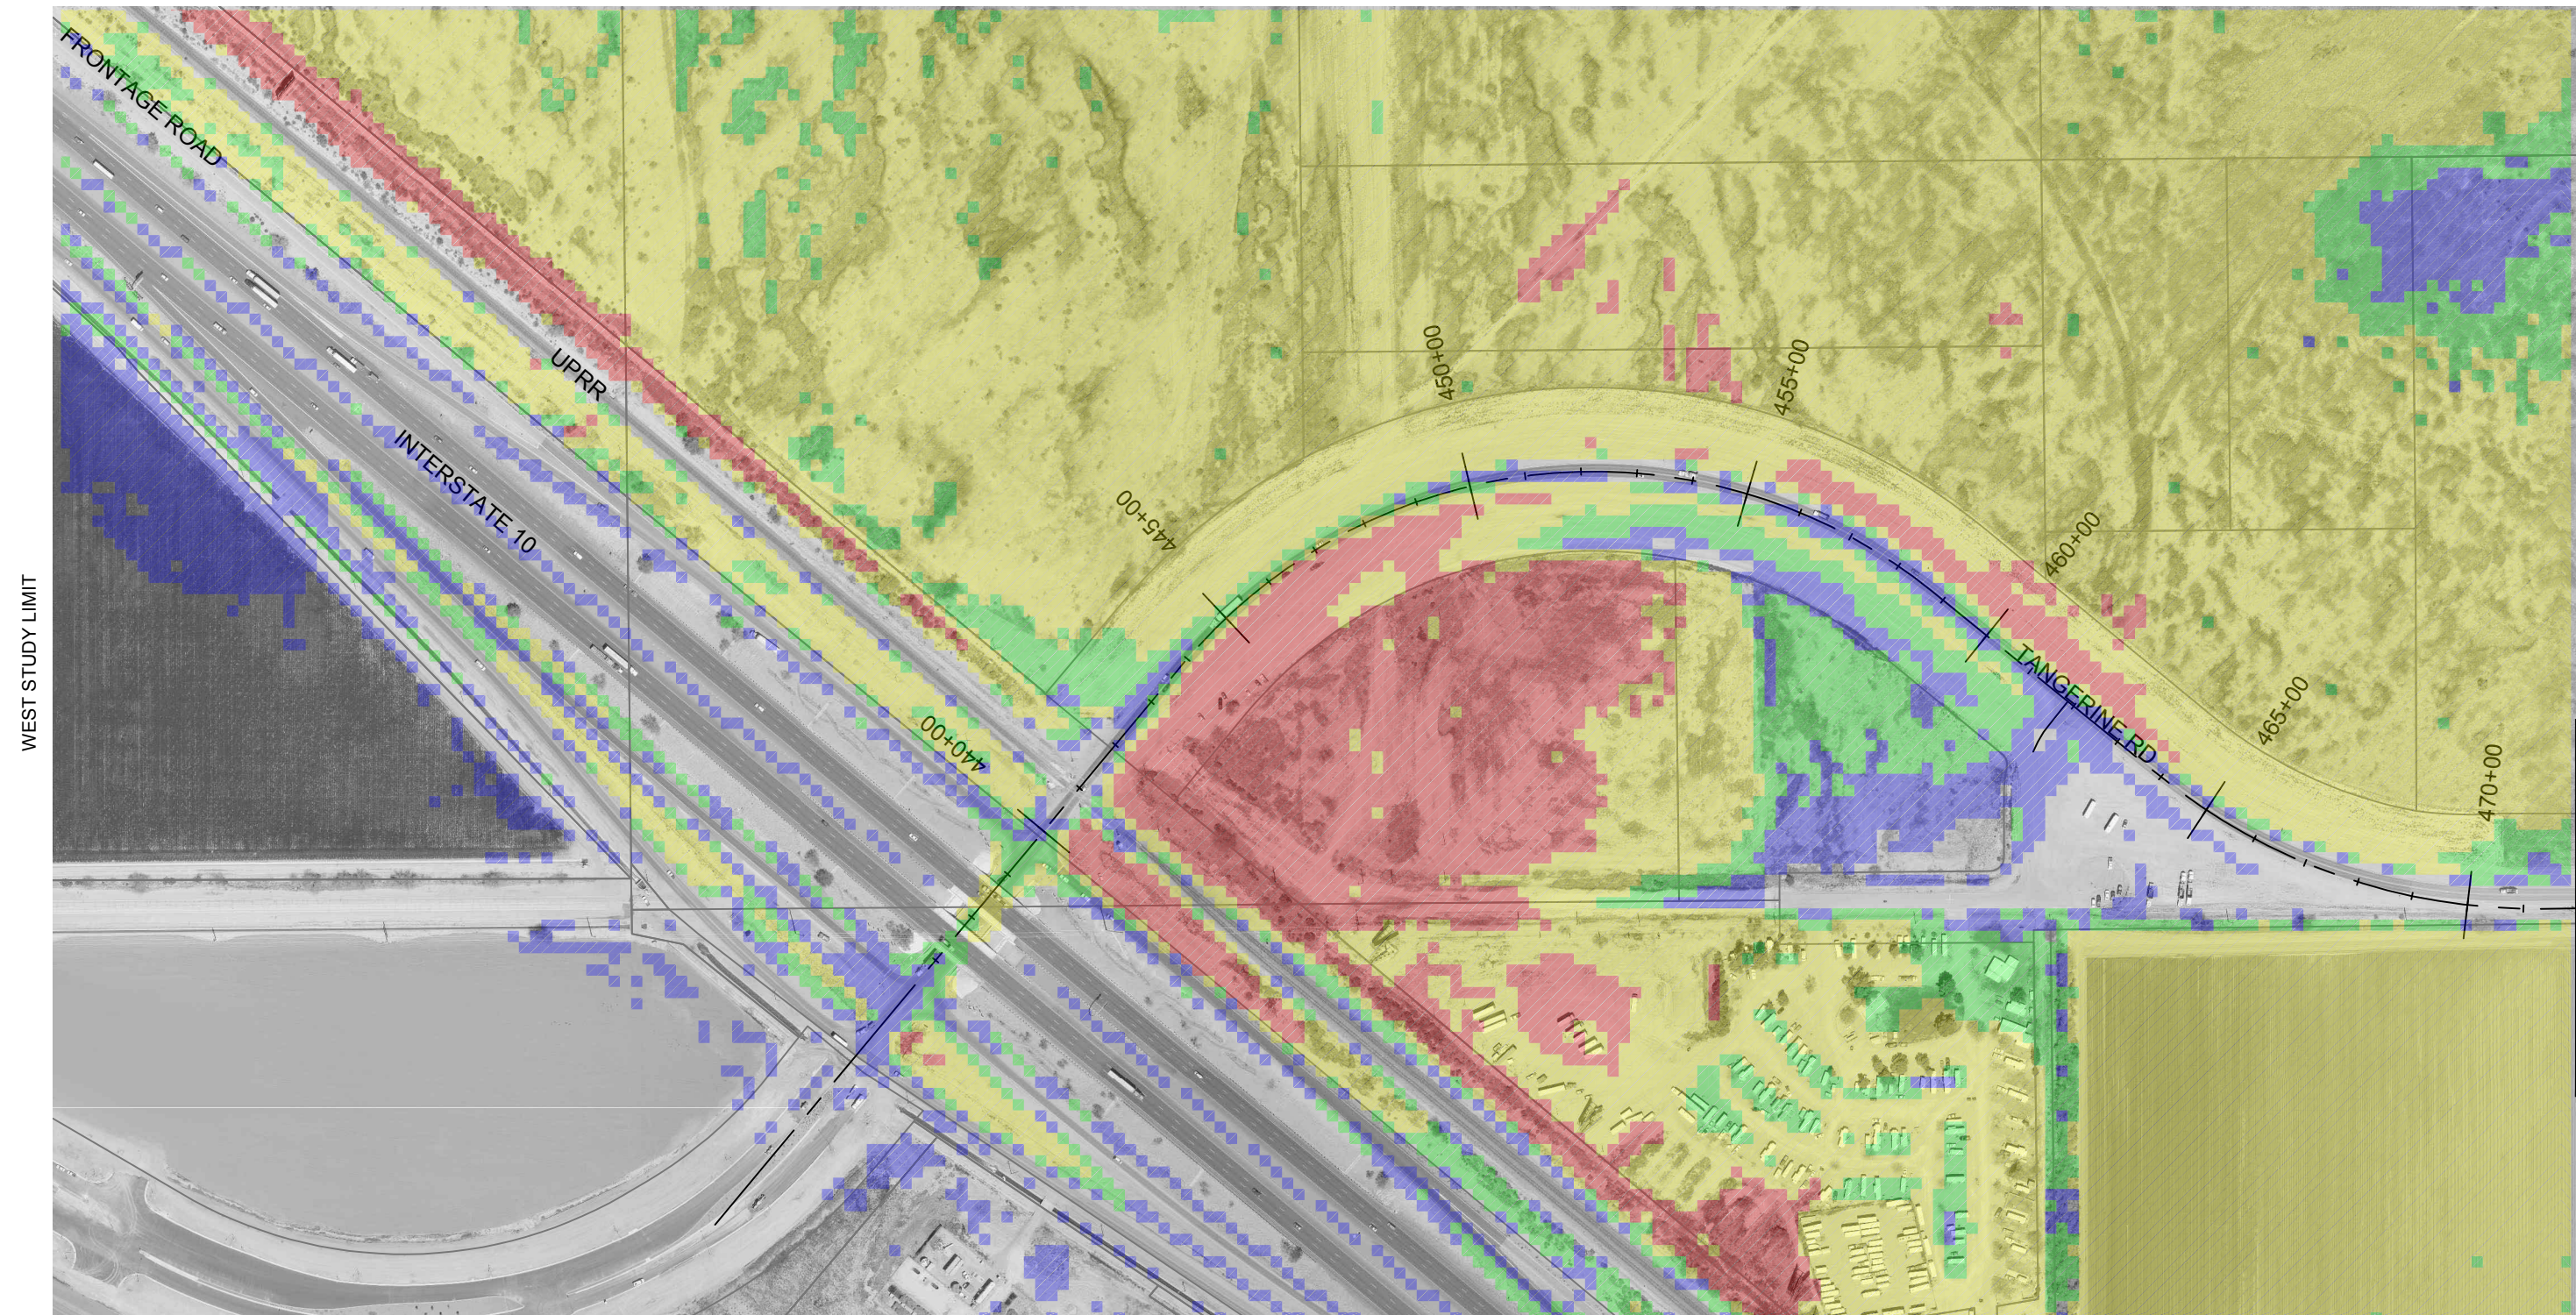
FIGURE C-4
EXISTING 100-YR FLOW DEPTHS AT TANGERINE RD.
 TANGERINE WEST END FLO-2D
 SHEET 1 OF 2

WEST STUDY LIMIT

MATCH STA. 472+00 - SHEET 2 OF 2

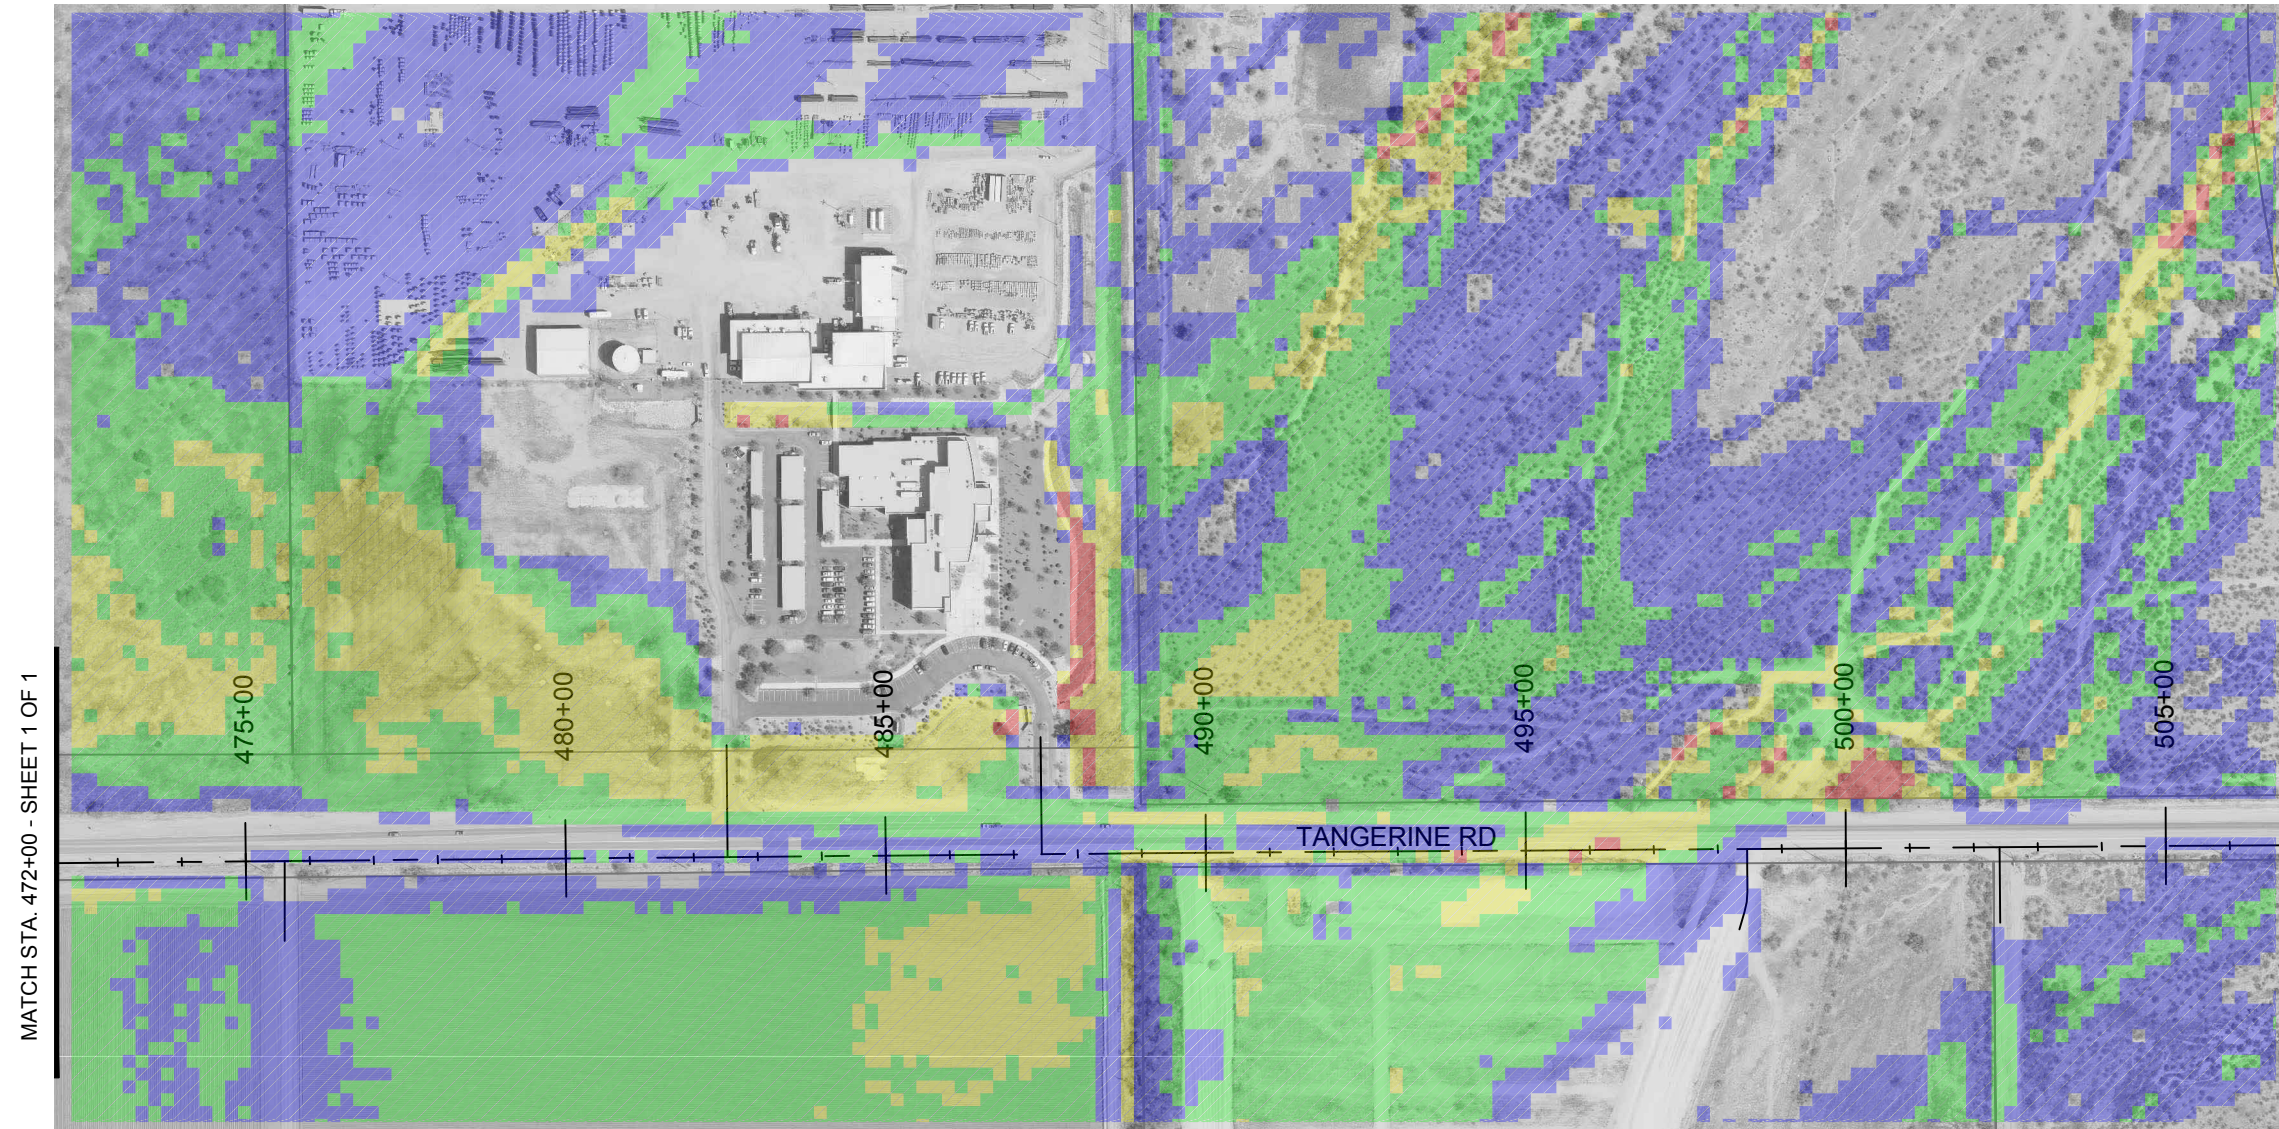
FIGURE C-5
EXISTING 10-YR FLOW DEPTHS AT TANGERINE RD.
 TANGERINE WEST END FLO-2D
 SHEET 2 OF 2

MATCH STA. 472+00 - SHEET 1 OF 1

STA. 507+00 - EAST STUDY LIMIT
